**SYSON-HILLE
and
ASSOCIATES**

Re: **POWLEDGE vs. GENERAL MOTORS CORPORATION**

REPORT OF STEPHEN R. SYSON - PAGE 1

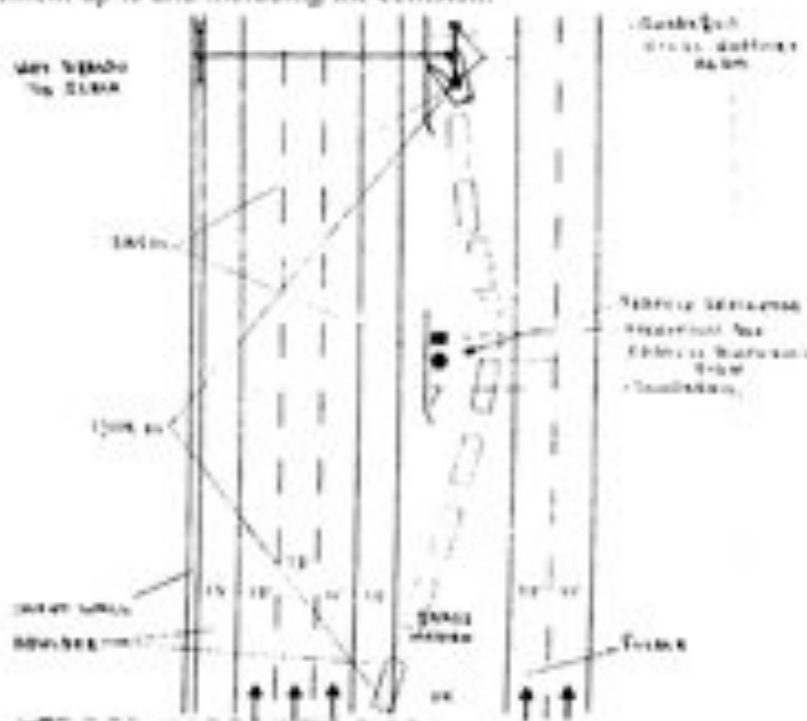
D. To determine if this was an intentional event, one must also look at the events before the actual impact. The police accident diagram illustrates the vehicle movement up to and including the collision:

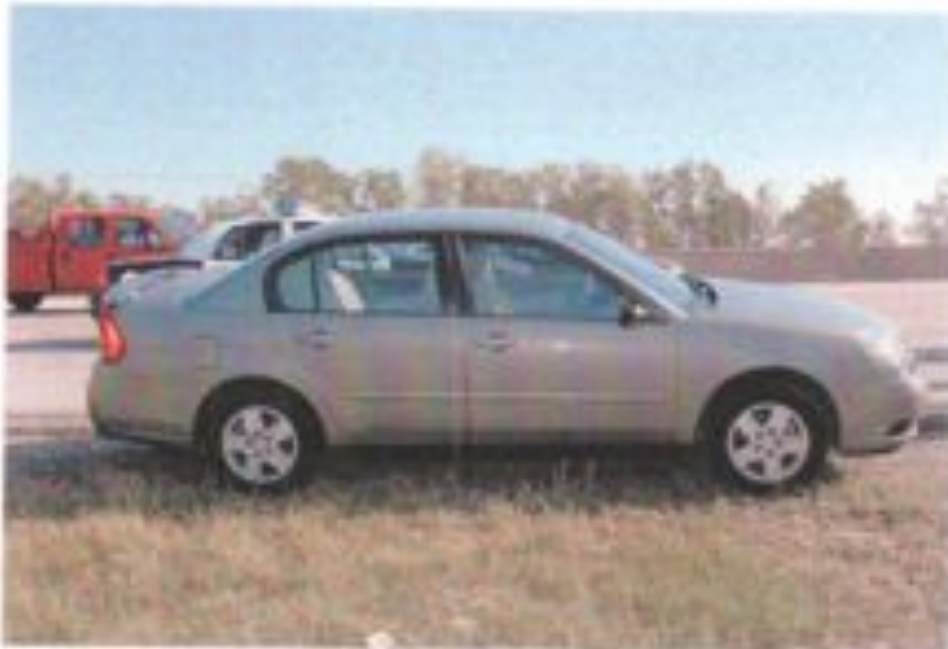
- F. Mr. Powledge was able to steer and control his vehicle and thus avoided striking several vehicles that were on I-45. He managed only to slightly sideswipe another Malibu side mirror to side mirror before leaving the travel lane of I-45 and entering the grass median. Damage to the other Malibu is shown below:

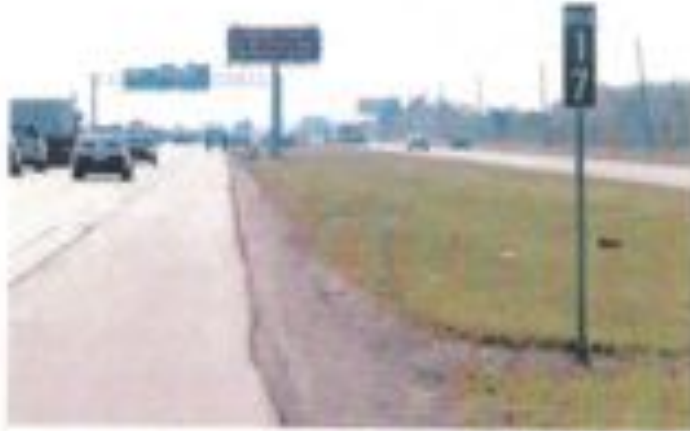
- G. After his departure from the southbound travel lanes of I-45 into the grass median, Mr. Powledge was able to steer and control his vehicle such that he managed to avoid a guardrail, a large electric box, a reflector post, and a traffic information sign pillar by moving toward the opposite side of the median. Based on the initial travel path of the Powledge vehicle after the vehicle left I-45, it appears that Mr. Powledge was trying to get onto the feeder road.

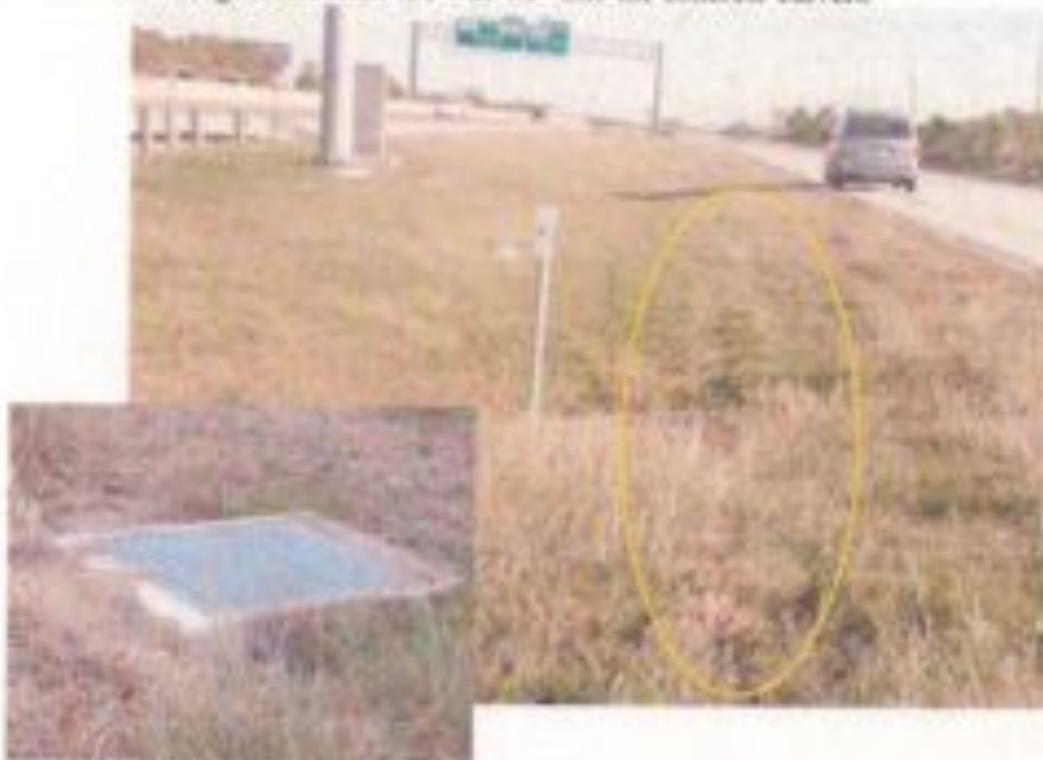
- H. Photographs provided by Laurie Williams that were taken by her husband Michael 7 days after the accident still clearly depict the tire marks made by Mr. Powledge's vehicle. The Williams' photographs and the Scientific Analysis photographs taken October 30, 2005 reveal that as Mr. Powledge reached the far side of the median after avoiding the obstacles described above, he contacted the top of a cement and steel drainage culvert with his left side front tire. This culvert was never photographed by the police or mentioned by the police in the scene diagram. The culvert has a sharp edge that is several inches tall. Measurements by Scientific Analysis taken on October 30, 2005, revealed that the centerline of Mr. Powledge's left front tire was 1.3' into the concrete culvert.

- I. The concrete culvert edge damaged the left front inner wheel and punctured the tire. The wheel and tire damage affected Mr. Powledge's ability to steer and control his vehicle.

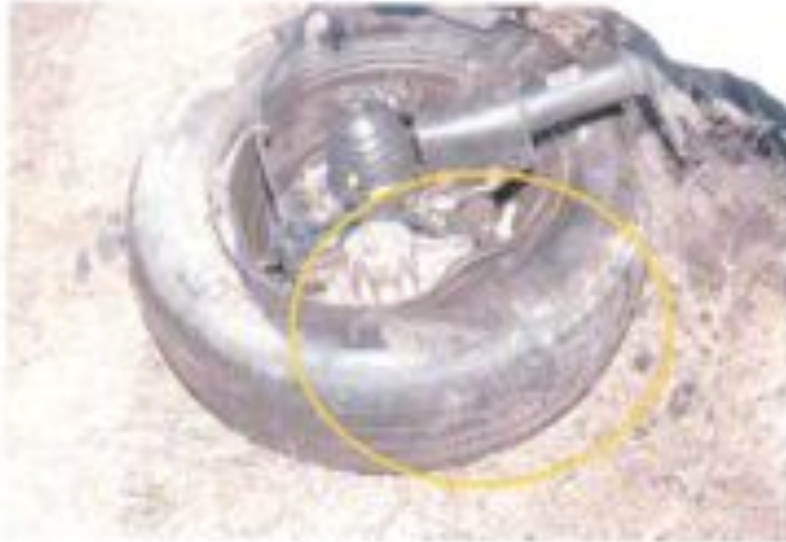
- J. The contact with the drainage culvert is evident in a police photograph where there is clearly a "curb strike" type dent in the rim and a large cut in the tire at the same position. This event would have rapidly deflated his left front drive tire and immediately pulled the Powledge vehicle back to the left (toward the middle of the grass median).

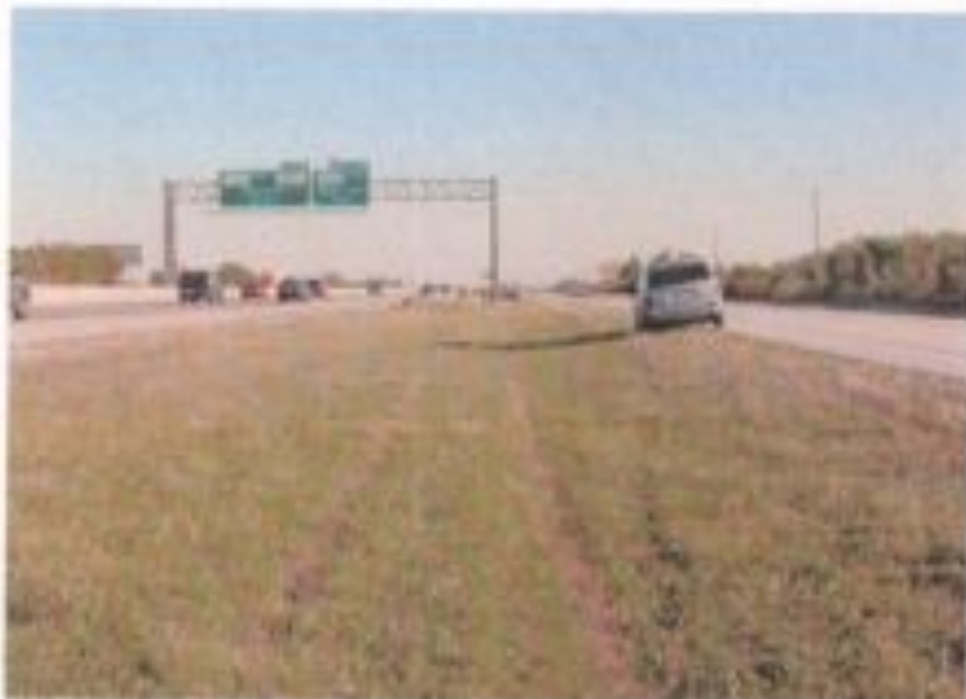
- K. Scene measurements by Scientific Analysis regarding the grass median include: width 50'; west side slope is 7 degrees; east side slope is 10 degrees; depth is 2'; flow line is 24' wide. The sloped sides would re-direct Mr. Powledge's vehicle back to the center of the grass median and make steering even more difficult to the right (toward the feeder road).

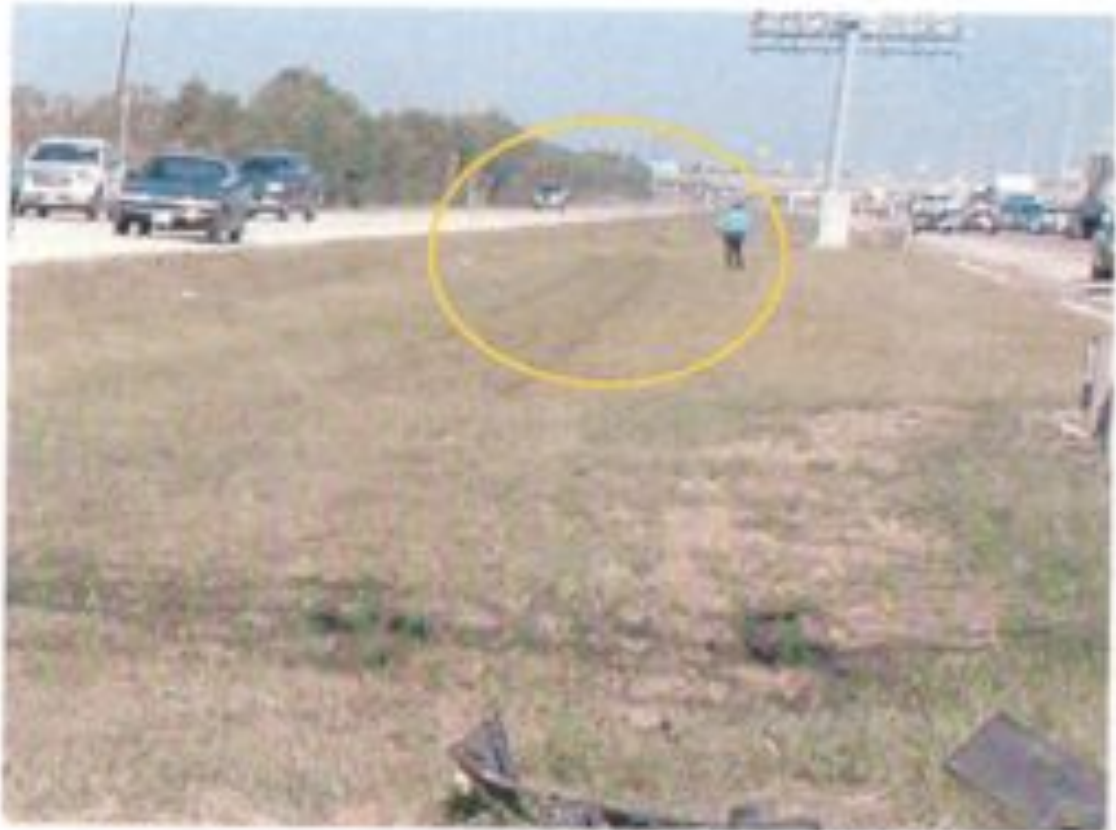
The re-directed motion of the vehicle back to the left (middle of the median) is evident in numerous photographs. As Mr. Powledge's vehicle moved left toward the flow line of the median and the deflated tire and bent wheel affected his steering and control capability, these conditions would tend to straighten out the vehicle into the lowest portion of the median.

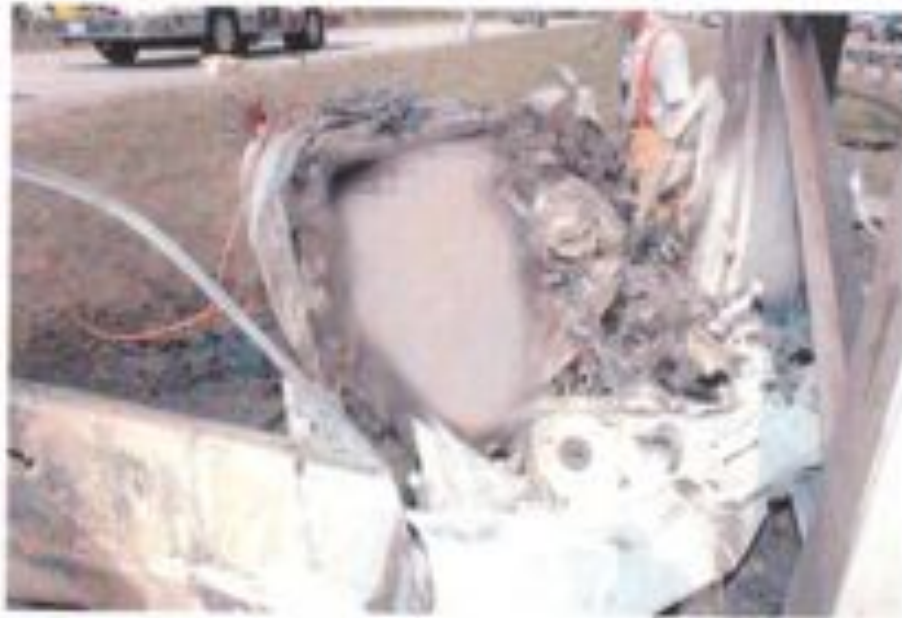
- M. During the last 700' of this accident after striking the concrete culvert with the left front tire, Mr. Powledge's brakes were ineffective, his engine was racing and his steering was not overly effective since the left front tire was deflated and his left front wheel was bent.
- N. Even though the deflated left front tire and damaged wheel affected Mr. Powledge's steering and control capability, there is evidence from the police photos that clearly demonstrate that Mr. Powledge's vehicle did not strike the sign support structure in a direct head-on manner. Instead, these photographs show that the impact was offset to the far left-side of the vehicle consistent with a person that was trying to steer around the obstacle.

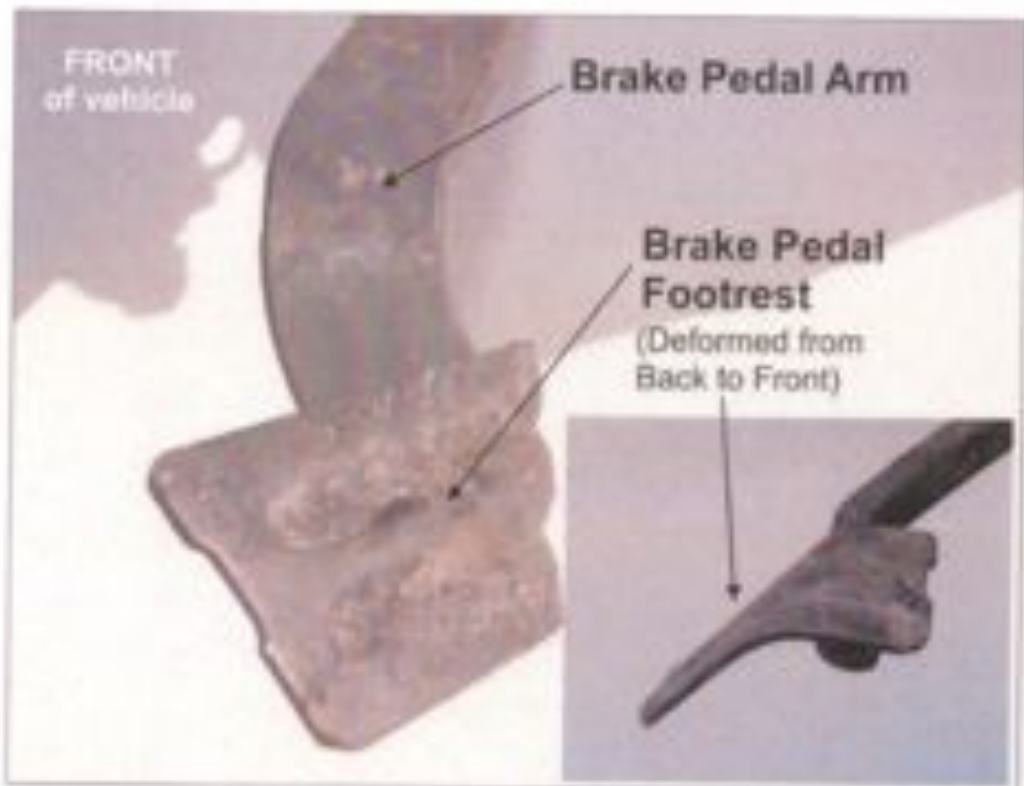
- Q. During one of my many inspections of the subject vehicle, the brake pedal was located. The brake pedal has significant deformation in the forward direction. In other words, the flat part of the pedal that your foot applies pressure to is bent from the rear to the front of the vehicle. This almost conclusively proves that Mr. Powledge had his foot on the brake pedal at the time of the impact. If Mr. Powledge was trying to commit suicide, it does not make sense that he would be applying his brakes at the moment of impact.

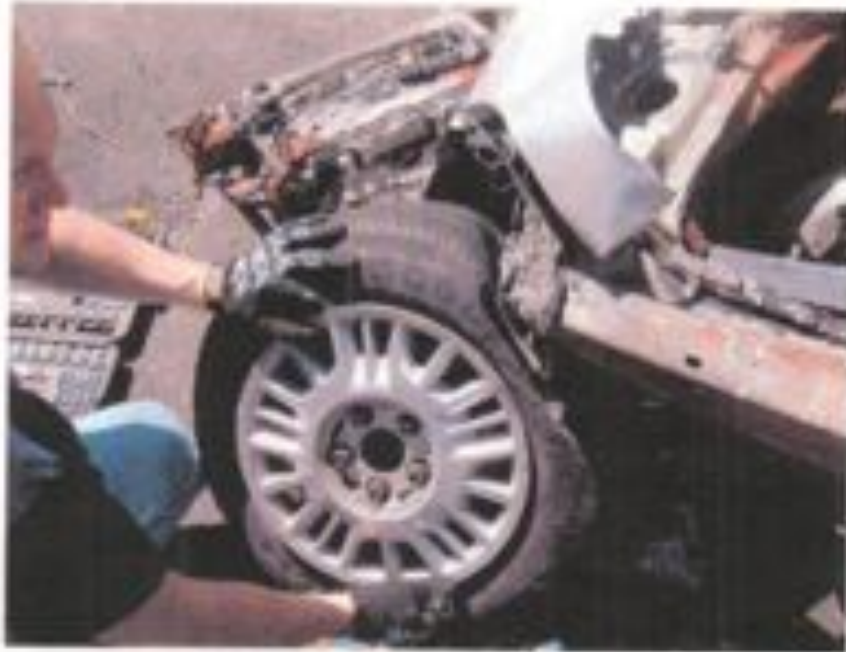
- P. The left front brake pads on the subject vehicle were overheated, despite there being little or no fire damage to that part of the Malibu Classic. In fact, the rubber tires are still intact.

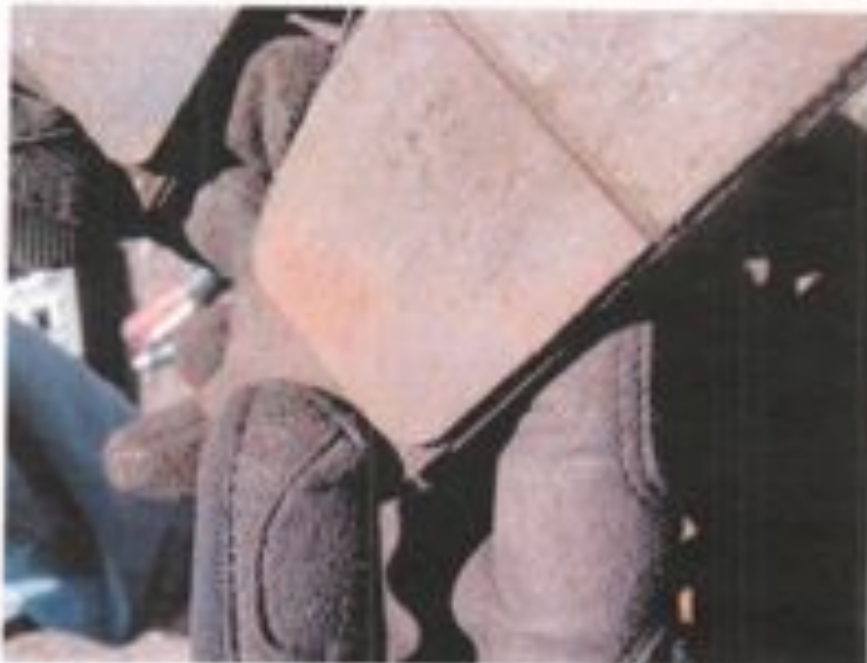
- Q. The brake pad material is overheated and spalled, indicating hard brake/pedal application. If Mr. Powledge was trying to commit suicide, it does not make sense that he would apply his brakes to this extent before the impact.

- E. Pedal misapplication can also be ruled out due to the brake pad spalling and disrupted grass and soil in the median.
- F. The totality of evidence supports proper brake pedal application, not improper gas pedal misapplication.

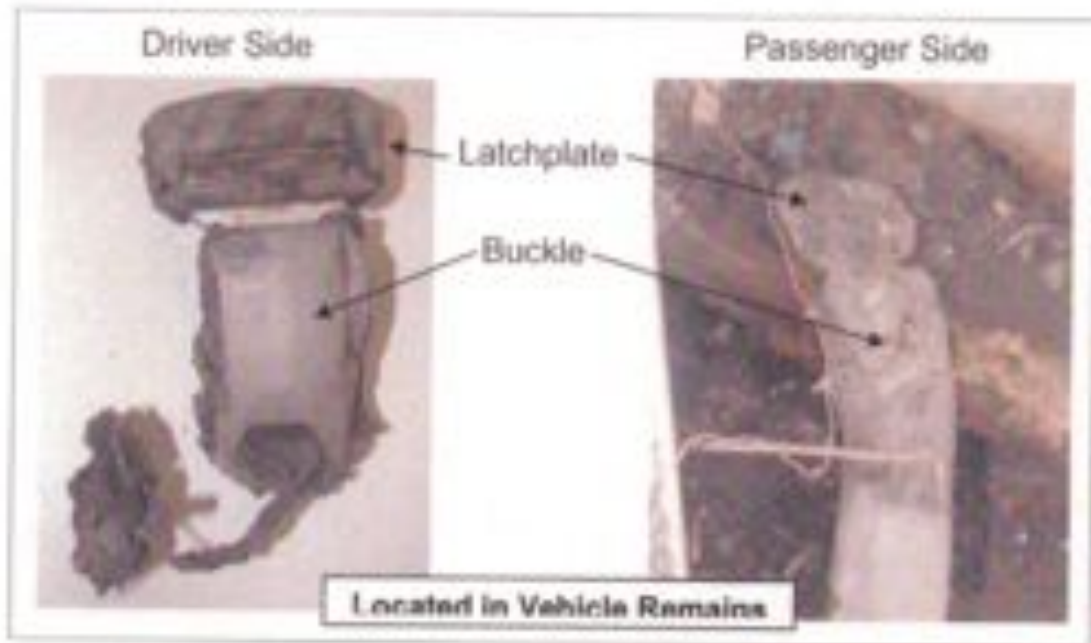
The driver's latch plate and buckle was located among the debris. The driver's latch plate is still in its respective buckle. It does not make sense that a person predisposed to killing himself in a vehicle crash would buckle up for safety before killing himself.

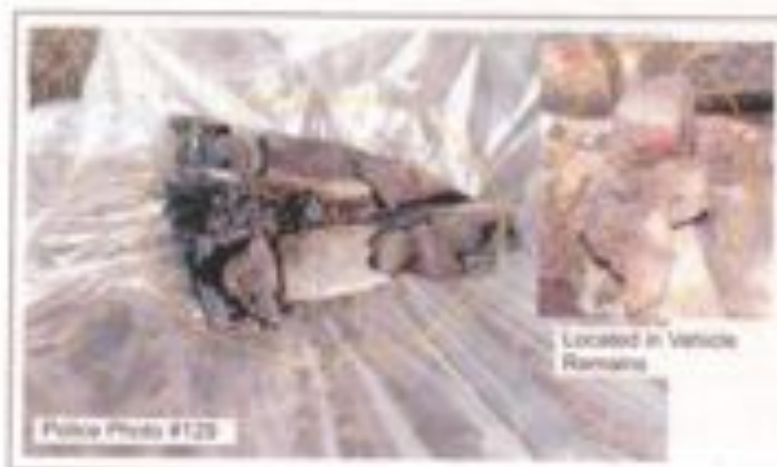
- S. Further, the buckle from the right front and one buckle from the rear seat were located in the debris. The latch plates were likewise in place in each of these buckles. Photographs taken by the police have the other two rear seat buckles documented. Again, the latch plates are inserted. It does not make sense that a man intent on killing all of his children would make them buckle up for safety before he killed them in a vehicle crash.
- T. The police report indicates that seat belt status was "unknown." However, the evidence proves that all 5 occupants had their seat belts buckled at the time of the accident.

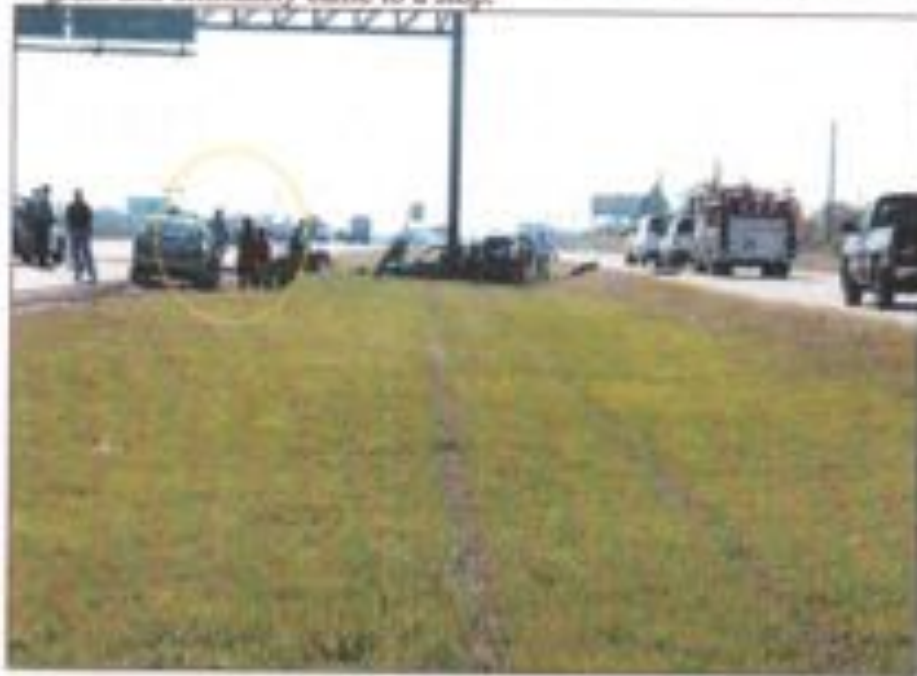
Lastly, the police photos show that the tire marks left in the median grass from the subject vehicle appear very heavy and defined. Photographs taken 7 days after the accident still show the distinct tire marks and the torn grass and disrupted soil. The subject vehicle, a front-wheel drive with anti-lock brakes, would have a tendency to drag the rear tires along, while braking under full throttle (the rear not subject to the engine driveline). The rear tires would, however, be rotating, disrupting and tearing the soil and grass surface more so than just traveling at a high rate of speed with no braking. By contrast is the Malibu, whose side mirror was struck by Mr. Powlodge's vehicle during the accident that had pulled off into the median after being struck. The struck Malibu left no tire marks in the grassy median shown in the police photo, and we know it pulled onto the grass and ultimately came to a stop.

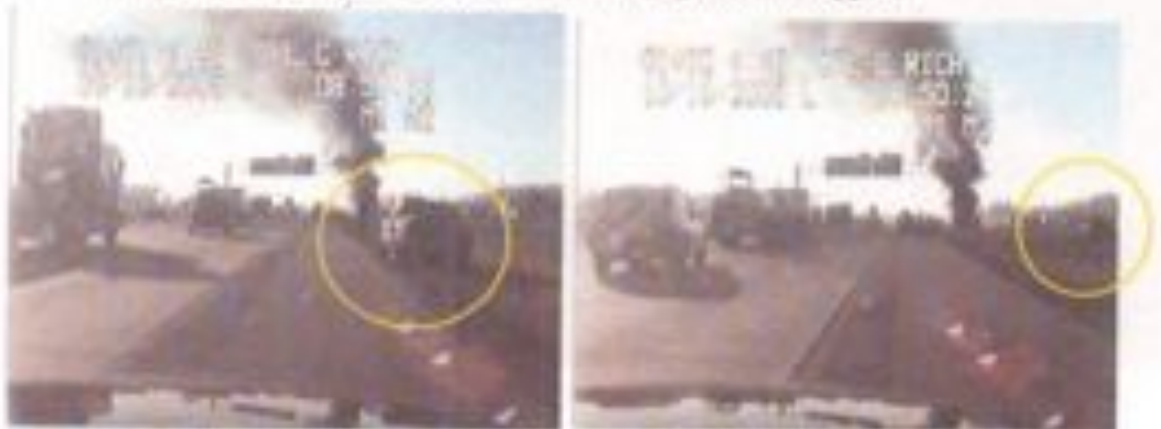
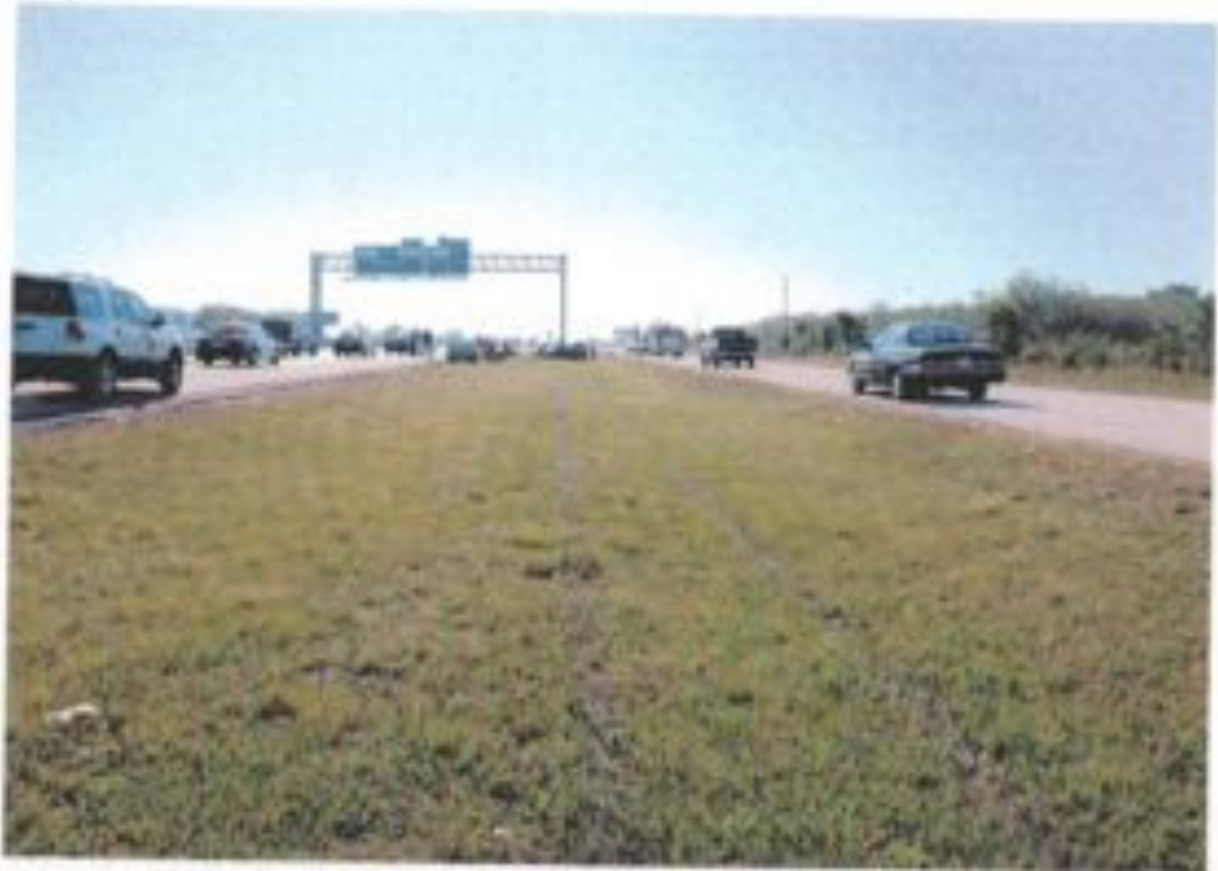
- V. I also watched Corporal Rich's cruiser video and noted that two trucks had pulled off into the median on opposite sides while the Powlodge vehicle was still on fire. The police photographs after the fire do not show that tire marks were left in the grass median from either of these vehicles even though we know they pulled onto the median grass and stopped.

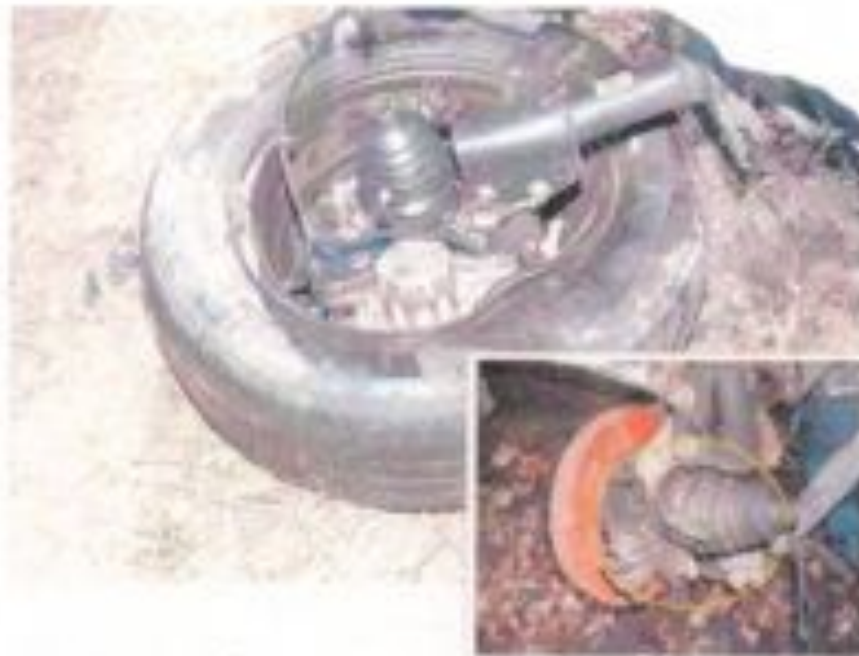
- A. Based on the tire marks in the grass median, the evidence is overwhelming that Mr. Powledge was braking at the time of the impact, and that he had been for a lengthy period of time before the impact. Naturally, the question becomes: why did his vehicle not stop?
- B. Contrary to GM's position in its build sheet for this particular vehicle, and in its answers to discovery, the subject vehicle clearly does have ABS components in place. These components are only used on ABS systems and were connected to the vehicle's wiring harness.

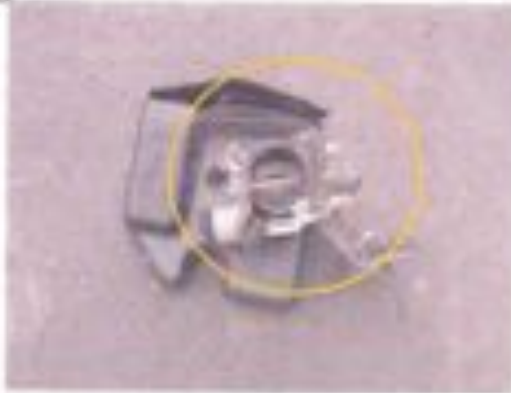
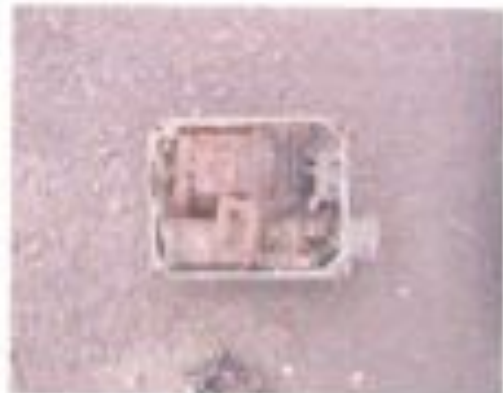
- I. I examined the remains of the vehicle to determine what was left of the power train. I found that both the engine and transmission had separated from their mount, and that both the engine and transmission had collision and fire damage. The intake manifold had either burned or broken off; however, the throttle body was located in the debris. It was stuck at the near full throttle position. There was a throttle cable connection, and a cable connection for a cruise control.

- B. Since the subject 2004 Chevrolet Malibu Classic engine's throttle control system is presently stuck 70 to 80% open, the throttle control system fails to meet FMVSS 124. Failure to comply with FMVSS 124 is negligence per se.

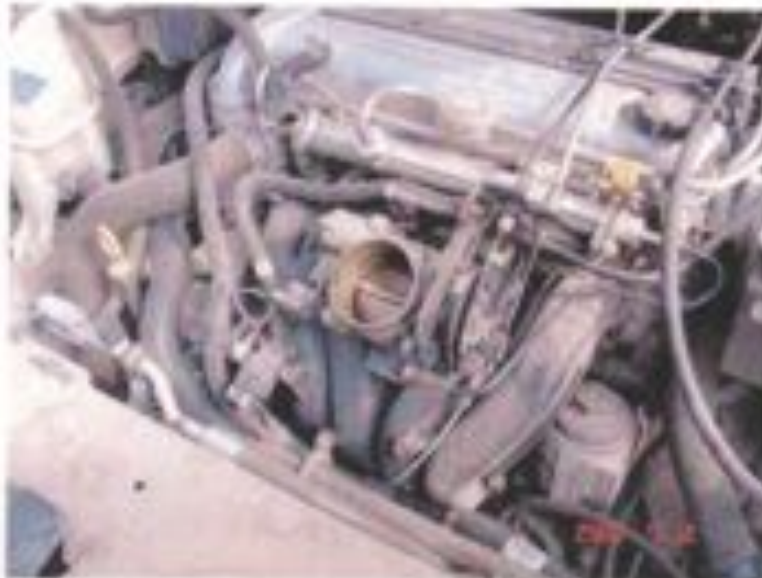
- J. I then inspected the power train of an exemplar 2004 Malibu Classic. The throttle was controlled by two cables. One cable attached to the throttle pedal, while the other attached to a stepper-motor type cruise control.

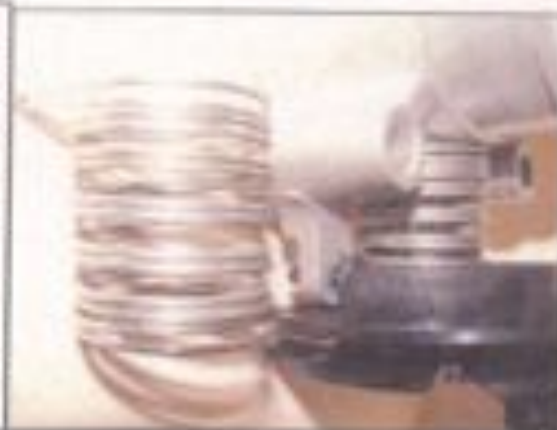
- N. If the throttle fails to close promptly when the driver takes his/her foot off the accelerator pedal, the throttle control system is in violation of FMVSS 124 (Accelerator Control Systems), both S5.1 and S5.3, which require redundant systems to close the throttle, and that the throttle close within a second after the gas pedal is released. If the cable guide moves off the throttle shaft, both springs disconnect from the throttle, and the throttle will not close. Such a single point failure is prohibited by FMVSS 124. An exemplar throttle body was purchased and disassembled to study the two spring connection. GM uses two springs that connect at the same positions. This unitized dual spring serves as the two distinct energy sources that FMVSS 124 requires to close the throttle. It is clear that GM's design of this unit is a violation of FMVSS 124 S5.1.

85.1 There shall be at least two sources of energy capable of returning the throttle to the idle position within the time limit specified by 85.3 from any accelerator position or speed whenever the driver removes the opposing actuating force. In the event of failure of one source of energy by a single severance or disconnection, the throttle shall return to the idle position within the time limits specified by 85.3, from any accelerator position or speed whenever the driver removes the opposing actuating force.

- O. A throttle control system, like that on the subject Chevrolet Malibu Classic, which does not meet FMVSS 124 is defective and unreasonably dangerous.

- A. Throttle control system that actually meets FMVSS 124.
- B. Drive by wire and integrated cruise control module, as used on the Malibu that preceded this vehicle by 3 months.
- C. Ignition cutoff under panic braking conditions.
- D. Fuel cutoff or fuel restrictor device.
- E. Relocate cruise control module so that it is free from EMI / RFI contacts, hot and cold temperature fluctuations as well as moisture and pollutants.
- F. Redundant fail safe designs so in the event of a failure, there is a "work around" system to prevent loss of system control.
- G. Speed sensitive acceleration cruise control based on European Patent 1375233A1.
